Rayex  
Plainville, Connecticut  
CTD982191785  
TDD# 9103-02-ATS

Site Inspection  
Final Report

July 1992

SITE INSPECTION  
RAYEX  
PLAINVILLE, CONNECTICUT

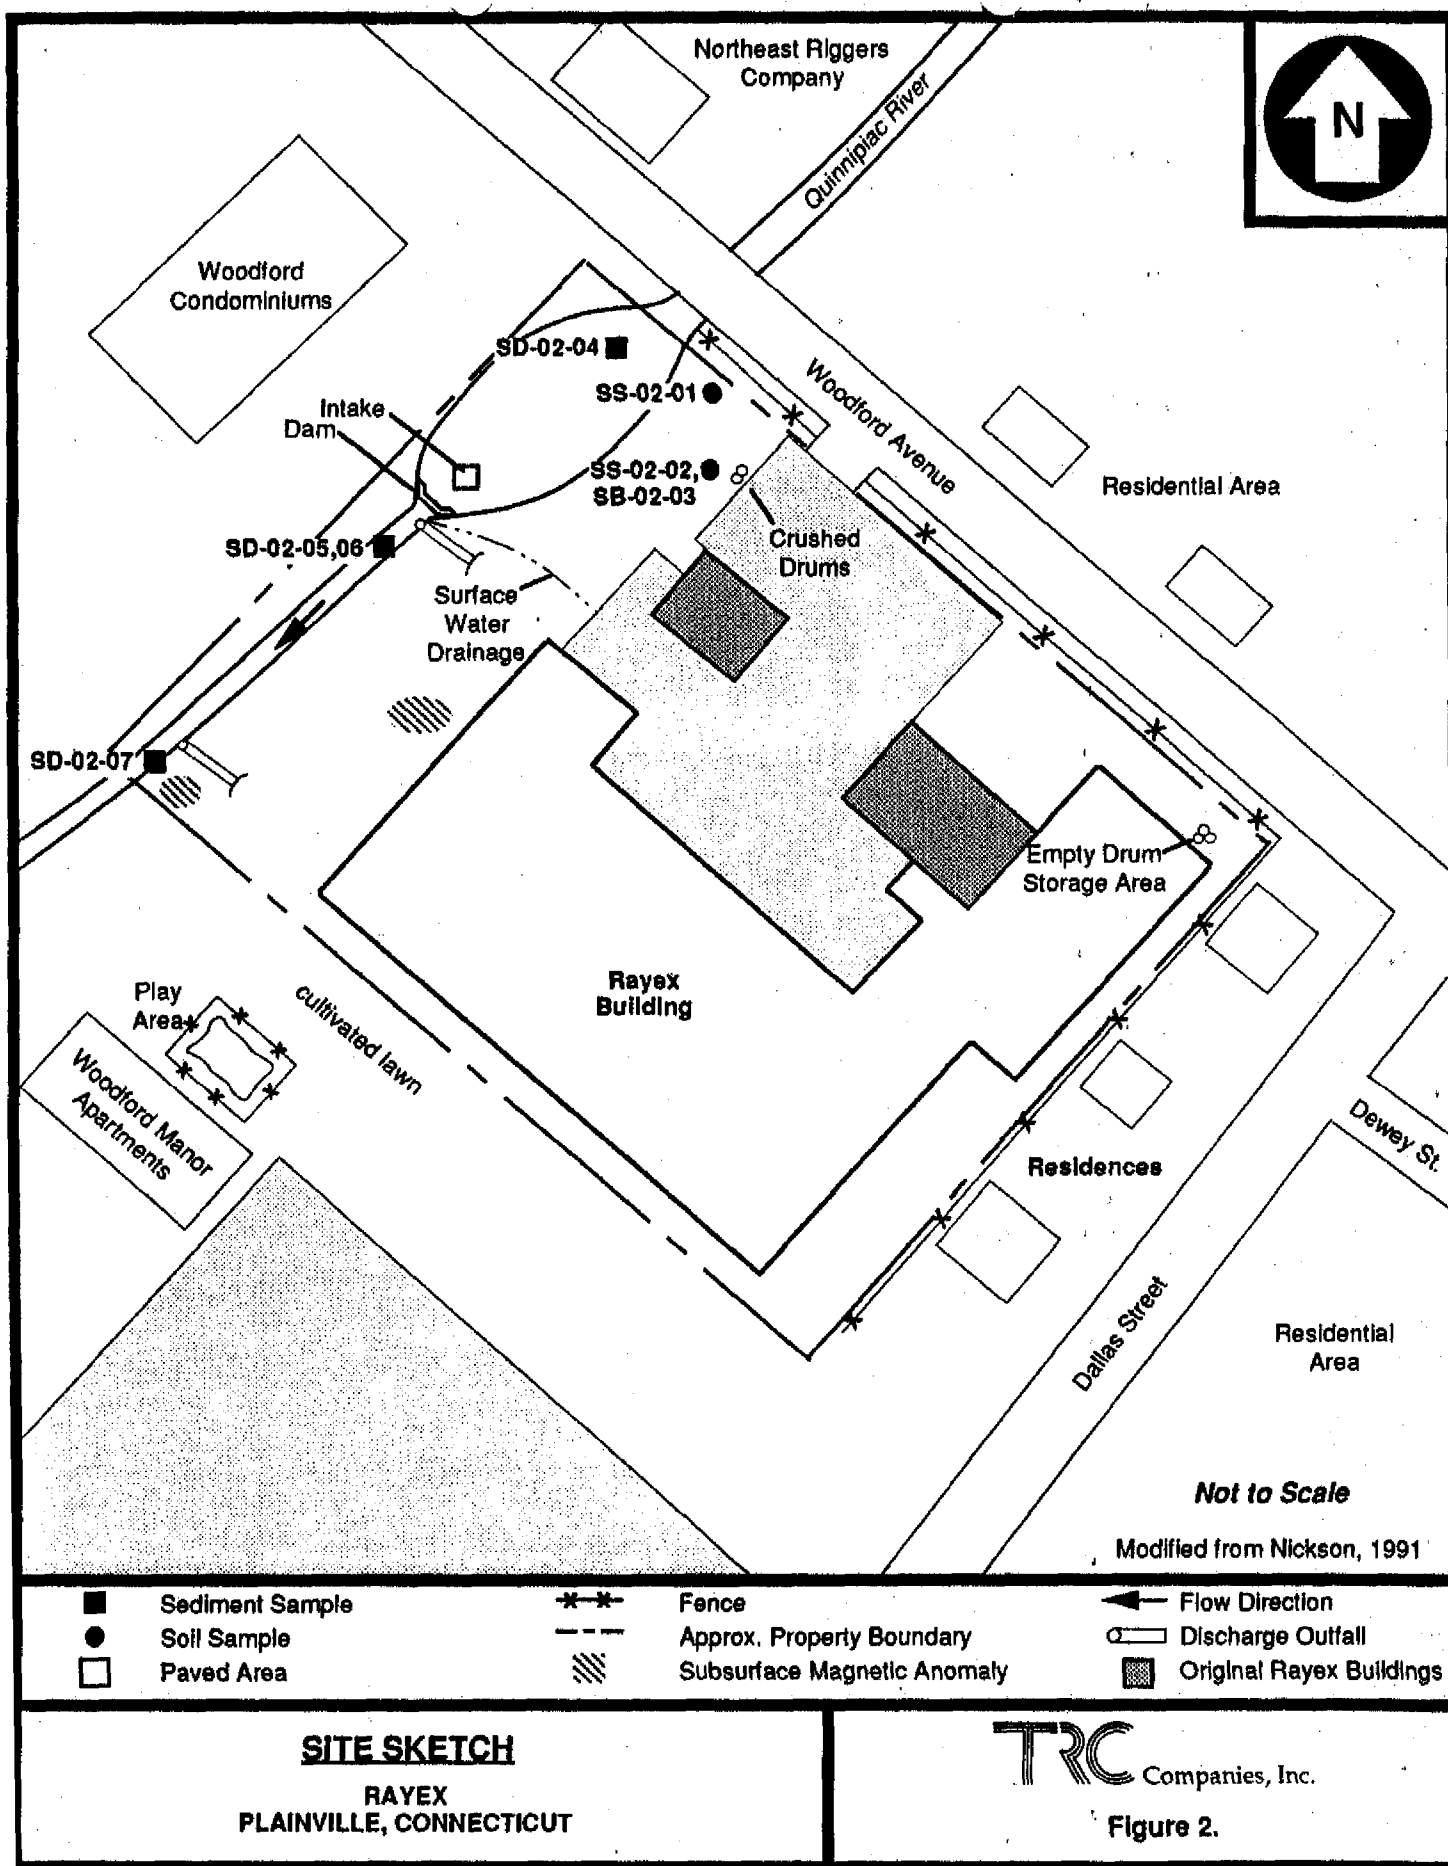
The original Rayex building consisted primarily of two buildings which were constructed in 1910 (Figure 2) (Plainville, 1986). One building housed the manufacturing operation and the second housed the boilers and other non-manufacturing equipment (TRCC, 1992a). When Rayex occupied the property, the only other man-made structure on the property was a small dam that was constructed across the Quinnipiac River in the 1940's (TRCC, 1992a). The dam was designed to create a small pond from which the building's occupants could draw water to power a freight elevator. The elevator is still functional. The used water is discharged back into the river through a four-inch pipe located four feet downstream of the dam. An addition to the manufacturing building was constructed in 1968 (Plainville, 1986). TRCC noted that surface water runoff from the paved area between the buildings had formed a distinct drainage channel into the river immediately below the dam. In addition, an oily sheen was noted on the river bank and in the river sediments during sampling (TRCC, 1992a). A storm water discharge pipe leading from the building's roof was noted protruding into the Quinnipiac River.

TRCC collected a total of eight samples, including three soil, four sediment, and one rinsate blank, from the Rayex property on January 3, 1992. Figure 2 illustrates the locations from which these samples were collected.

Sample SS-02-01, collected from an apparently undisturbed location 200 feet south of Woodford Avenue, contained significant concentrations of one VOC, twelve SVOCs, two pesticides, and two inorganics. Methylene chloride was detected in sample SS-02-01 at 35 micrograms per kilogram ( $\mu\text{g}/\text{kg}$ ). SVOCs, which were detected at concentrations ranging

Samples SD-02-05 and SD-02-06 contained the only contaminants detected in significant concentrations in sediment samples collected at Rayex. The samples were duplicates collected less than ten feet downstream of the discharge pipe and the surface water runoff ditch.
